Technical Report

GP-2 Methane Monitoring Summary and Assessment

South Dayton Dump and Landfill Site

Moraine, Ohio

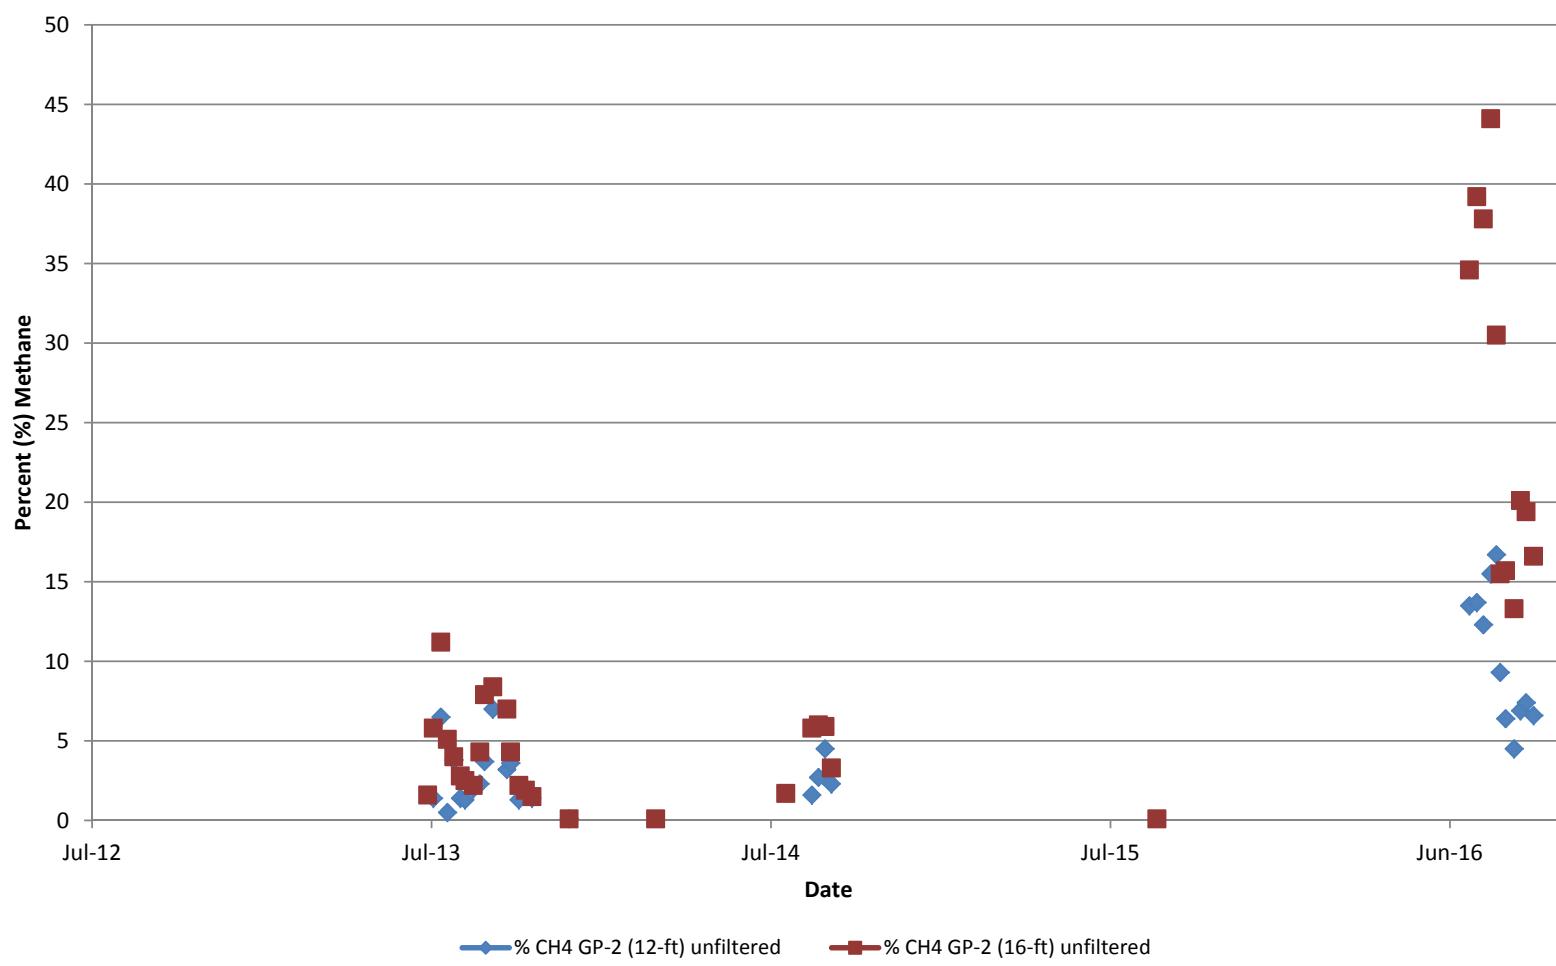
figure 3b

DETECTED UNFILTERED METHANE READINGS AT GP-2 (12- AND 16- FEET)
SOUTH DAYTON DUMP AND LANDFILL SITE
Morine, Ohio

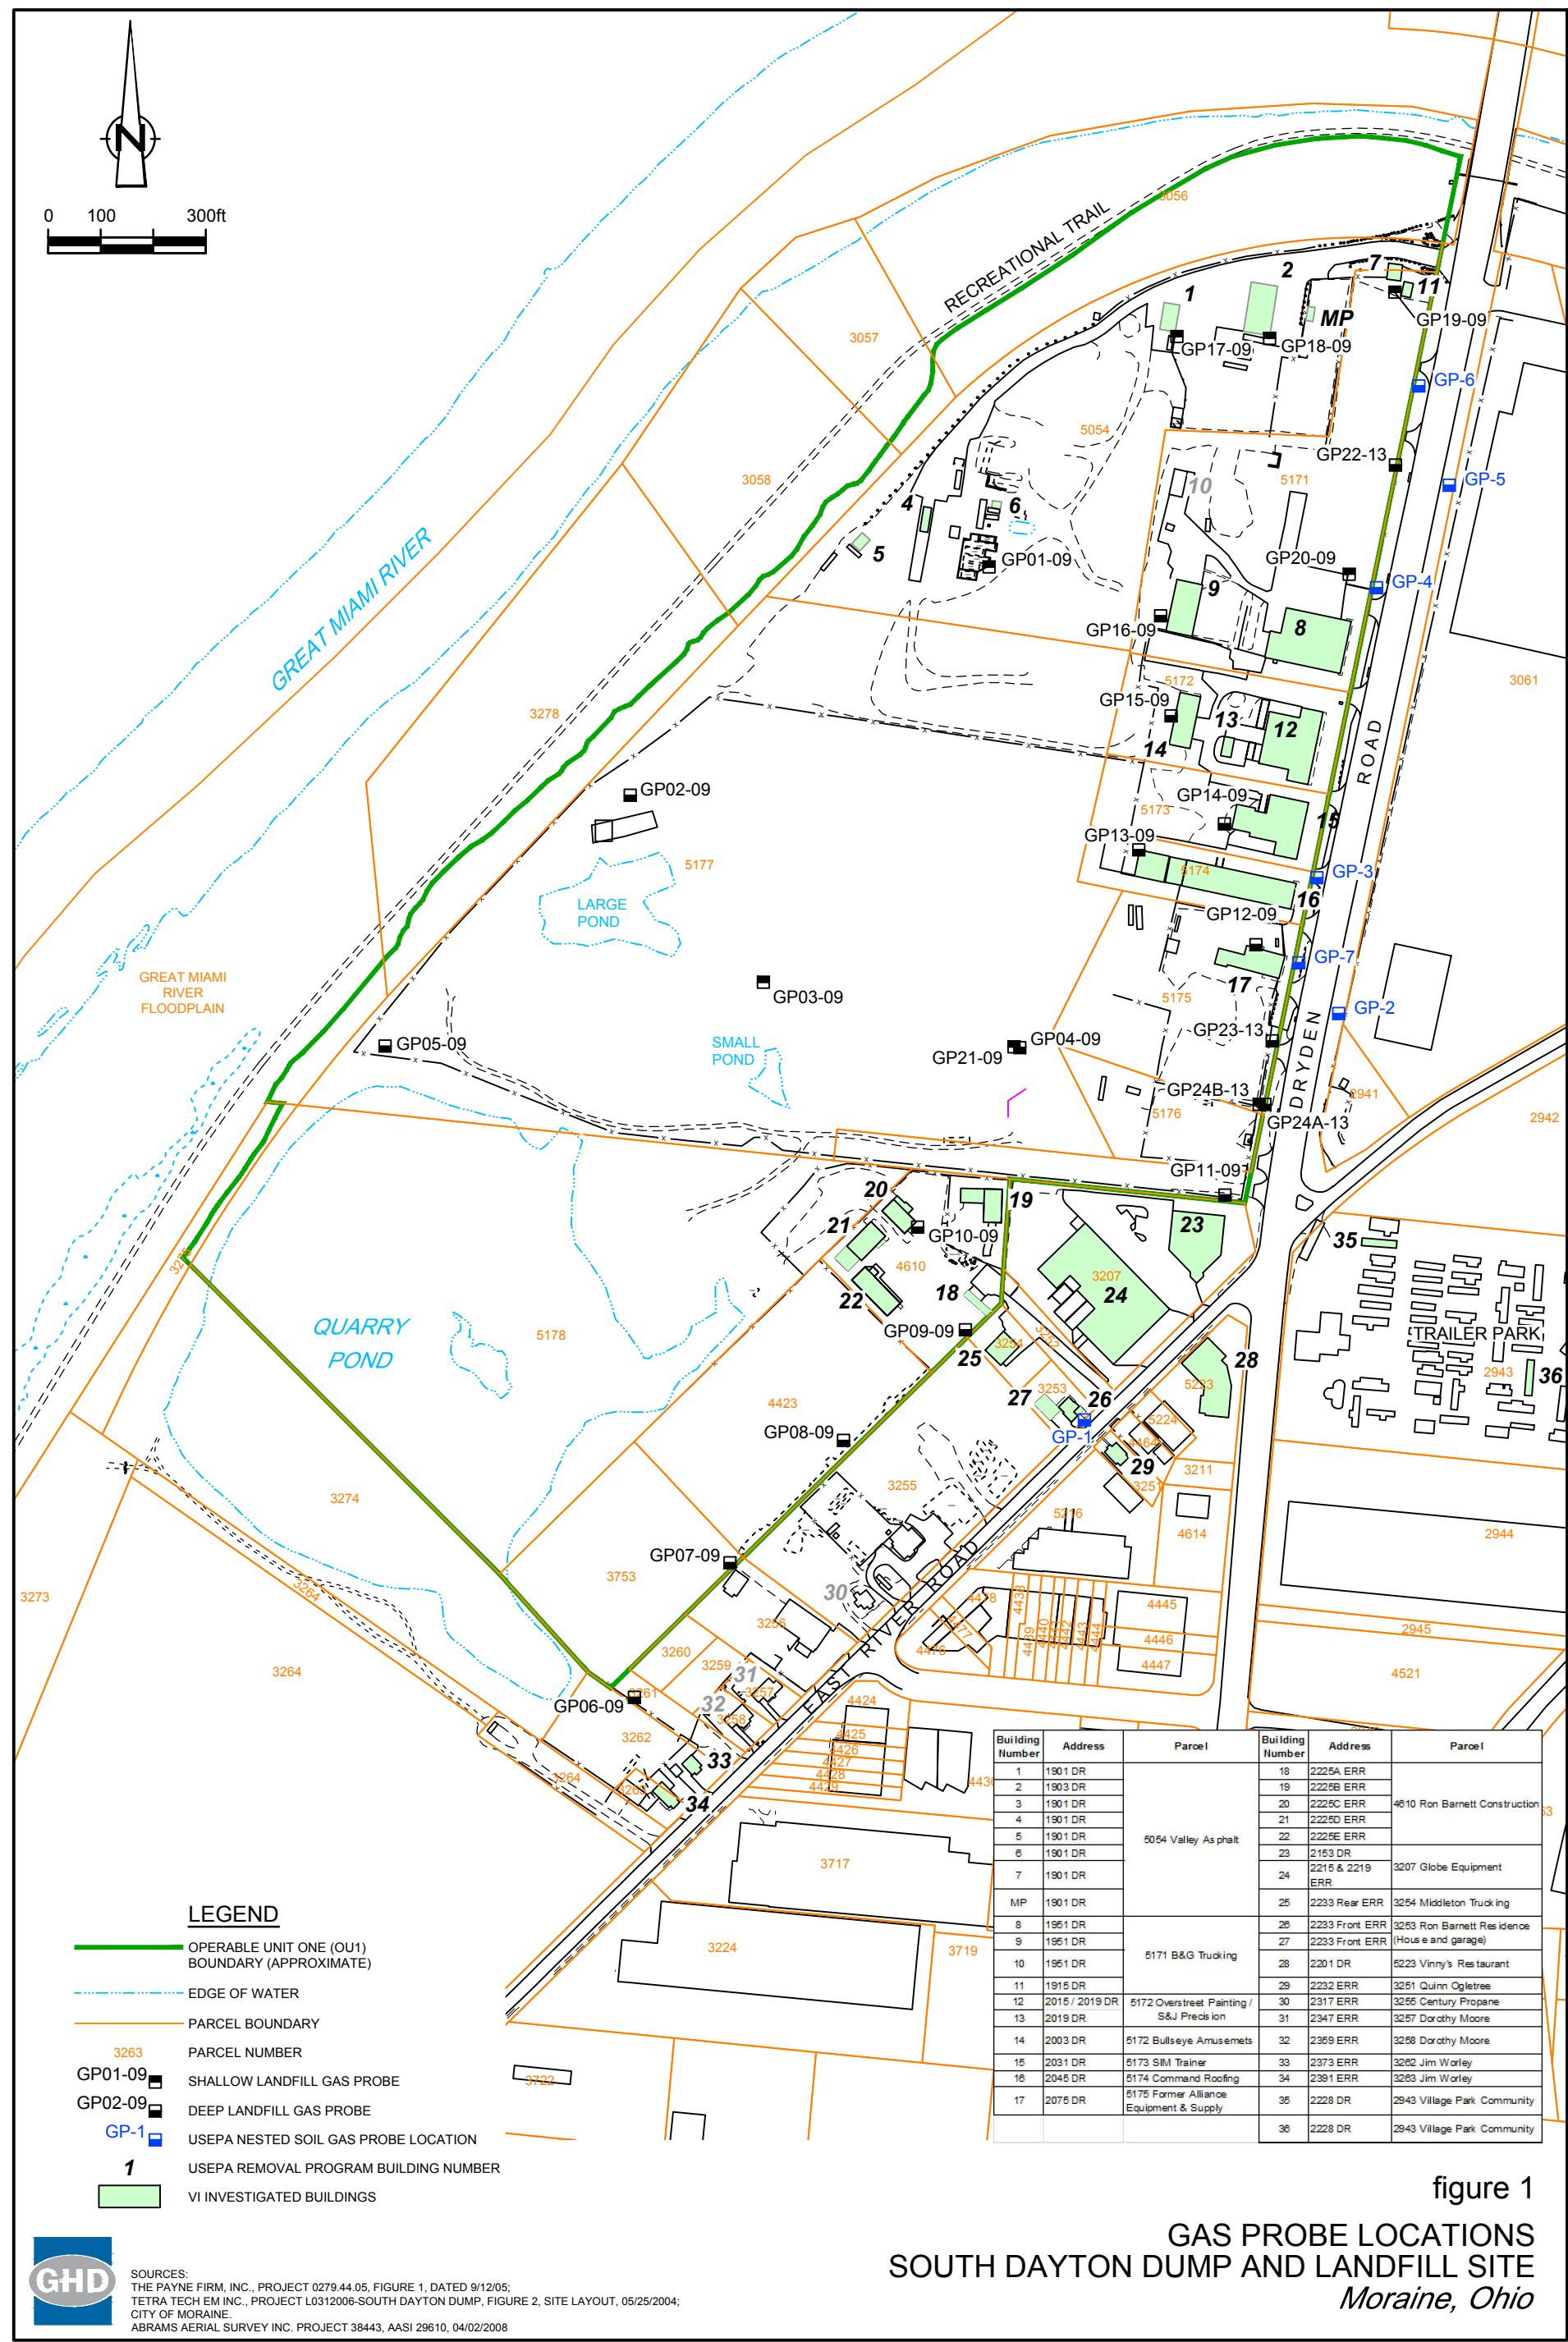
figure 1

GAS PROBE LOCATIONS SOUTH DAYTON DUMP AND LANDFILL SITE *Moraine, Ohio*

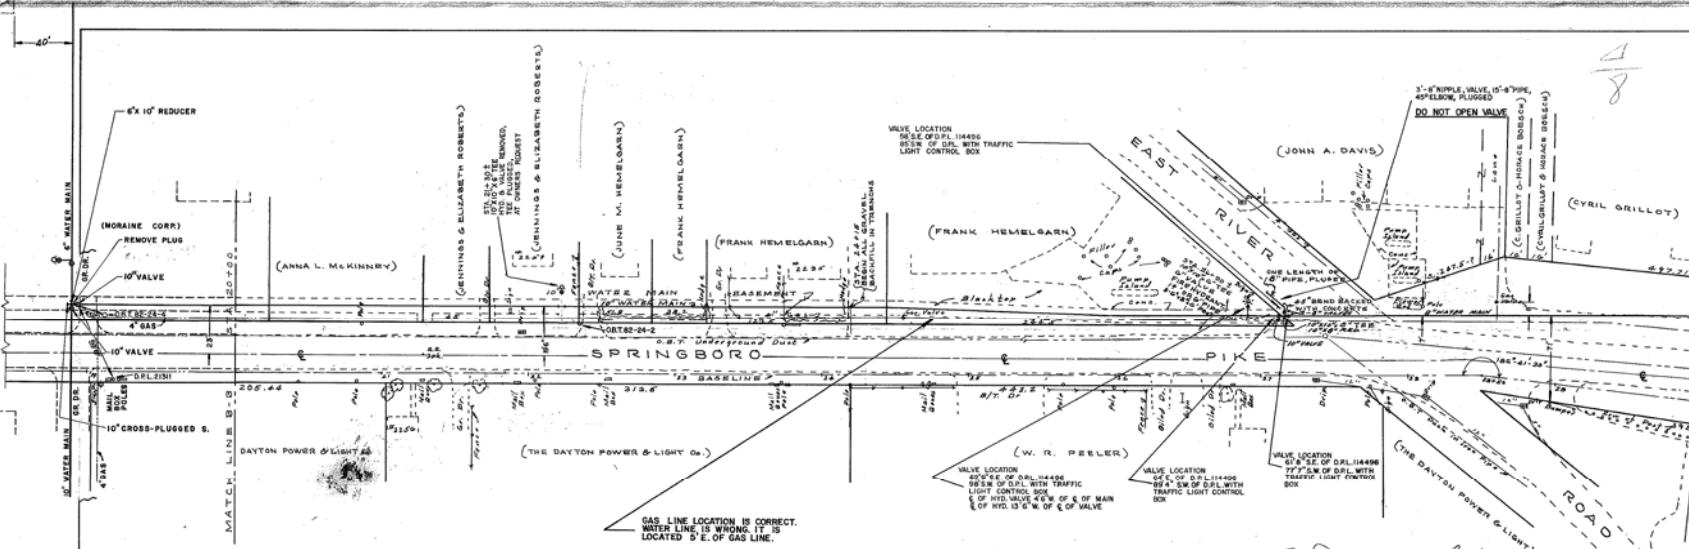
GAS LINE LOCATION IS CORRECT.
WATER LINE IS WRONG. IT IS
LOCATED 5' E. OF GAS LINE.
